**Flood Control Project Maintenance
Levee Inspections**

Fall 2013 Levee Maintenance Deficiency Summary Report

Tehama County Flood Control and Water Conservation District

Levee Inspection Report By Mile - Fall 2013

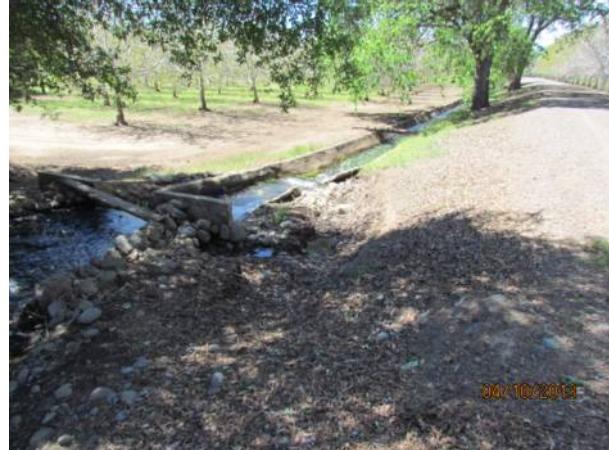
Levee Mile Report Line	4
Start Levee Mile	0.02
End Levee Mile	0.02
Location	Land Side
Category	Earthen Levee
Item	Erosion / Bank Caving

View of the erosion along the landside slope.

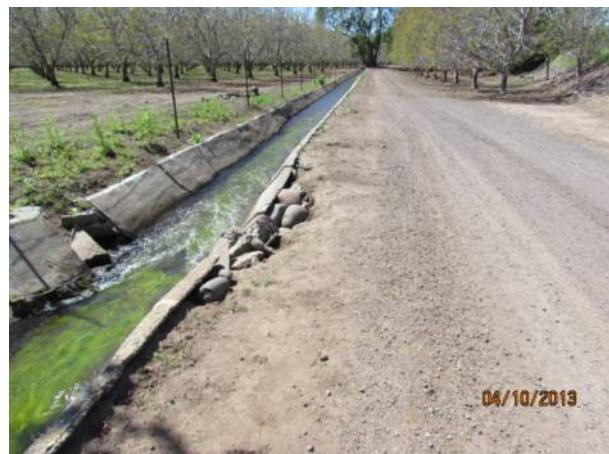
Levee Mile Report Line	5
Start Levee Mile	0.41
End Levee Mile	0.41
Location	Land Side
Category	Earthen Levee
Item	Erosion / Bank Caving

View of the erosion along the landside slope.

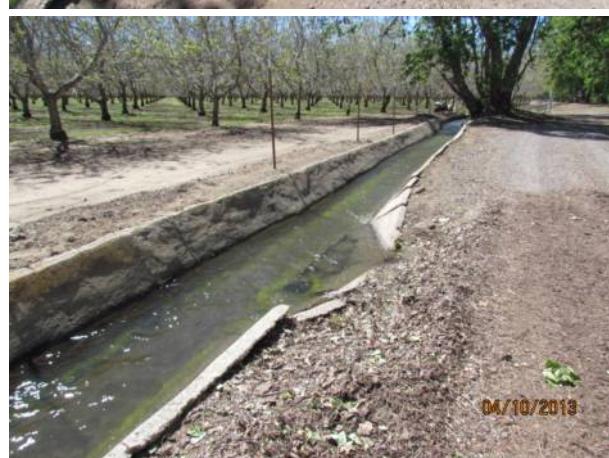
Levee Mile Report Line	6
Start Levee Mile	0.48
End Levee Mile	0.48
Location	Land Side
Category	Earthen Levee
Item	Erosion / Bank Caving

View of the erosion along the landside slope.

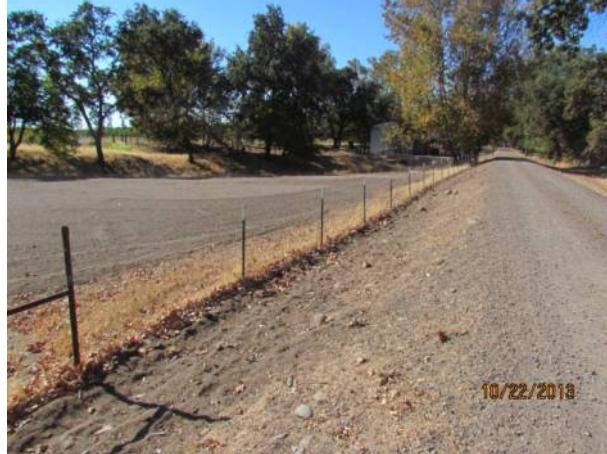
Levee Mile Report Line	7
Start Levee Mile	1.53
End Levee Mile	1.53
Location	Land Side
Category	Earthen Levee
Item	Animal Control
View of the erosion cause from livestock on both slope of the levee.	
rduffey_f_20131104_111.JPG

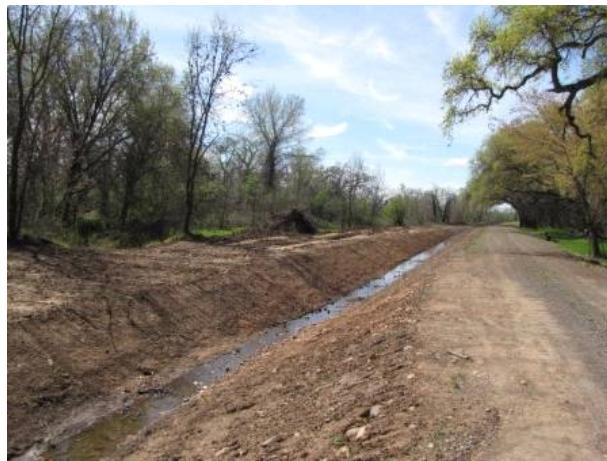
Levee Mile Report Line	8
Start Levee Mile	2.04
End Levee Mile	2.23
Location	Land Side
Category	Earthen Levee
Item	Encroachments
Remove agricultural ditch from toe of levee.	
rduffey_f_20130919_006.jpg

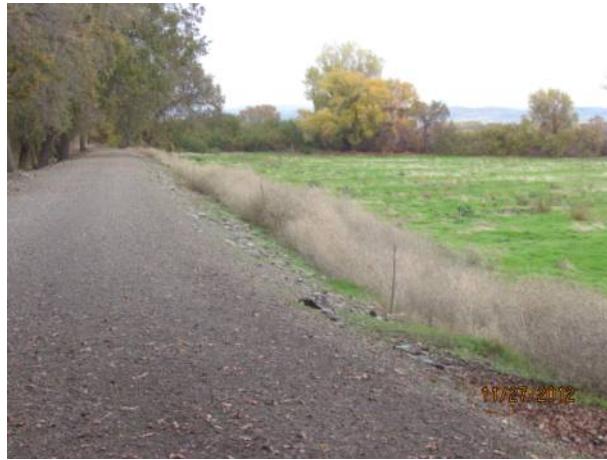
Levee Mile Report Line	9
Start Levee Mile	2.31
End Levee Mile	3.04
Location	Land Side
Category	Earthen Levee
Item	Vegetation
View of the vegetation along the landside slope.	
rduffey_f_20130919_007.JPG

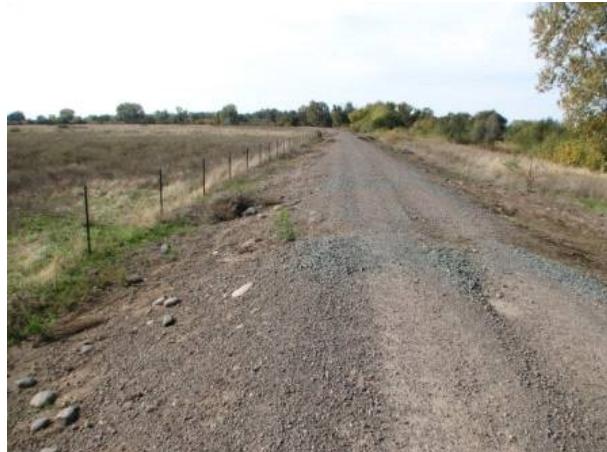
Levee Mile Report Line	11
Start Levee Mile	2.72
End Levee Mile	2.76
Location	Crown
Category	Earthen Levee
Item	Slope Stability
Erosion on crown and both slopes.	
rduffey_f_20130919_008.jpg

DWR ID: DWR_NA0019_01_s_2012_7
11	2.72 2.76	Earthen Levee	Slope Stability	CR M Ma	S2 : Repair the levee slope damaged by foot traffic and prevent access where possible.					39.965434 ° 39.965180 ° 8 -122.027776 ° -122.028331 ° Y	
											DWR ID: DWR_NA0019_01_s_2012_8
12	2.90 2.90	Earthen Levee	Slope Stability	LS M Ma	S1 : Repair slope instability.					39.963709 ° 39.963709 ° 20 -122.030384 ° -122.030384 ° Y	
											DWR ID: DWR_NA0019_01_s_2013_20

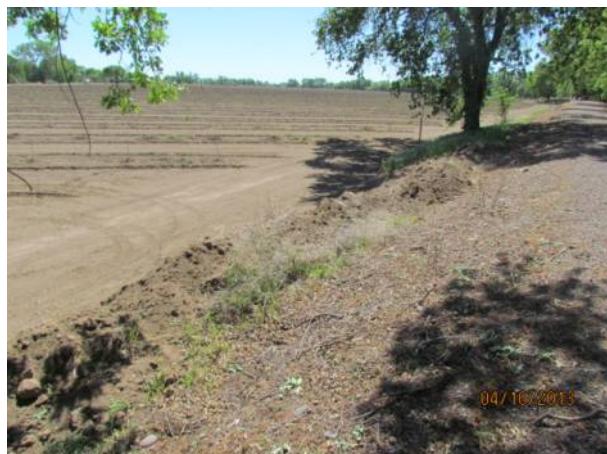
Levee Mile Report Line	12
Start Levee Mile	2.90
End Levee Mile	2.90
Location	Land Side
Category	Earthen Levee
Item	Slope Stability
View of the erosion along the landside slope.	
rduffey_f_20130919_017.JPG

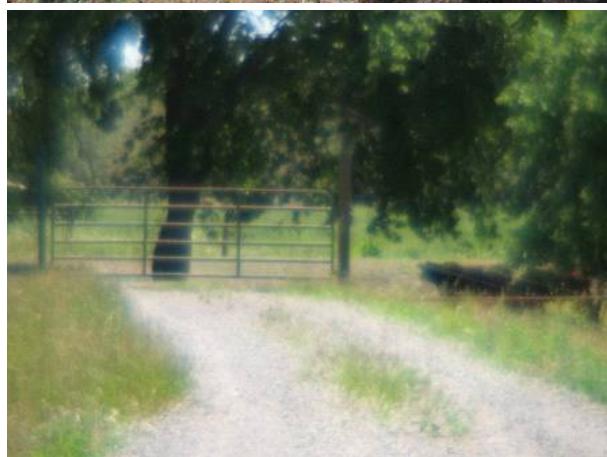
Levee Mile Report Line	14
Start Levee Mile	3.64
End Levee Mile	3.64
Location	Crown
Category	Earthen Levee
Item	Encroachments
View of the non-permitted gate on the crown of the levee.	
rduffey_f_20130919_009.jpg

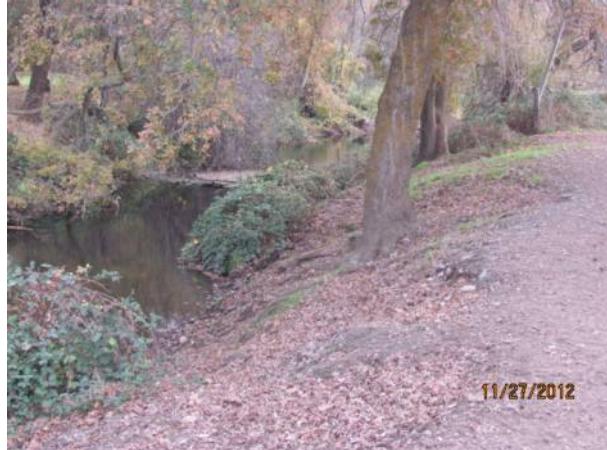
View of the erosion caused by livestock along the landside slope.

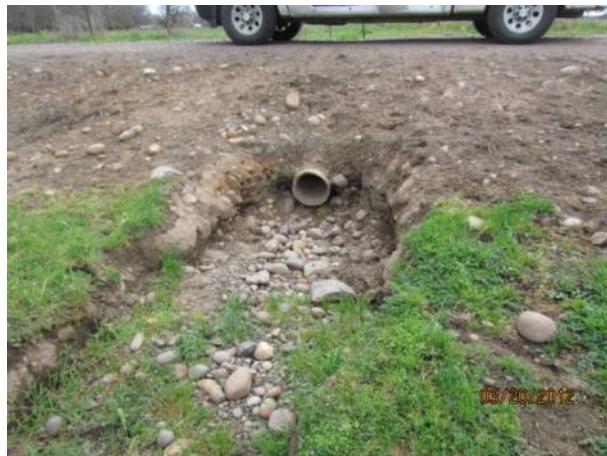
Levee Mile Report Line	16
Start Levee Mile	3.74
End Levee Mile	3.74
Location	Water Side
Category	Earthen Levee
Item	Encroachments

No flap gate on 18 inch pipe going to the levee.

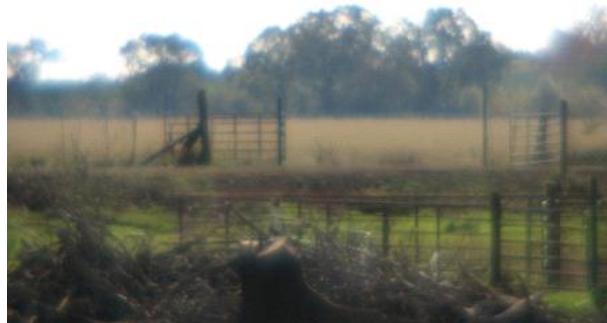
Levee Mile Report Line	17
Start Levee Mile	3.74
End Levee Mile	3.74
Location	Crown
Category	Earthen Levee
Item	Encroachments

View of the non-permitted gate on the crown roadway.

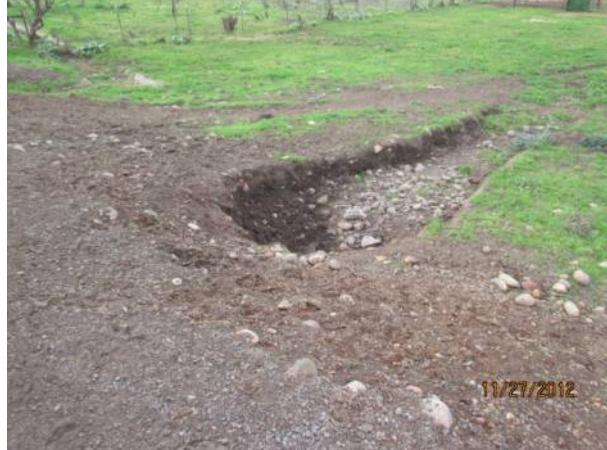
Levee Mile Report Line	18
Start Levee Mile	3.74
End Levee Mile	3.74
Location	Land Side
Category	Earthen Levee
Item	Encroachments
View of the ditch along the waterside toe.	
rduffey_f_20130919_013.JPG

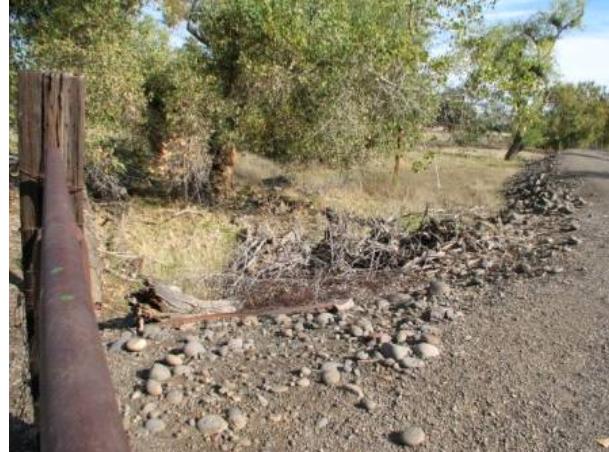
Levee Mile Report Line	1
Start Levee Mile	0.31
End Levee Mile	0.31
Location	Land Side
Category	Earthen Levee
Item	Encroachments
View of debris & wire at toe of levee.	
rduffey_f_20130919_018.jpg

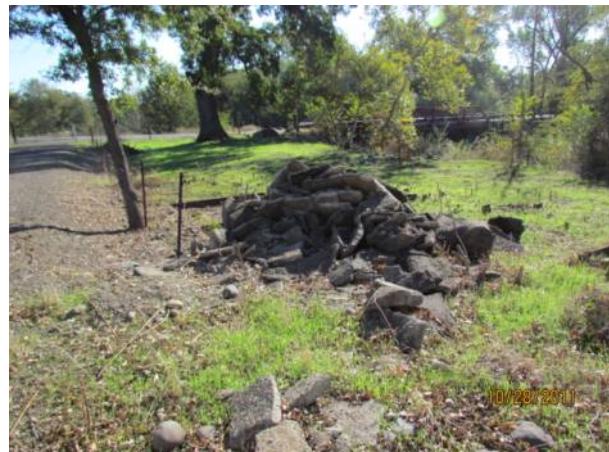
Levee Mile Report Line	2
Start Levee Mile	0.34
End Levee Mile	0.34
Location	Water Side
Category	Earthen Levee
Item	Encroachments
View of the concrete pile along the W/S toe.	
rduffey_f_20130919_019.jpg

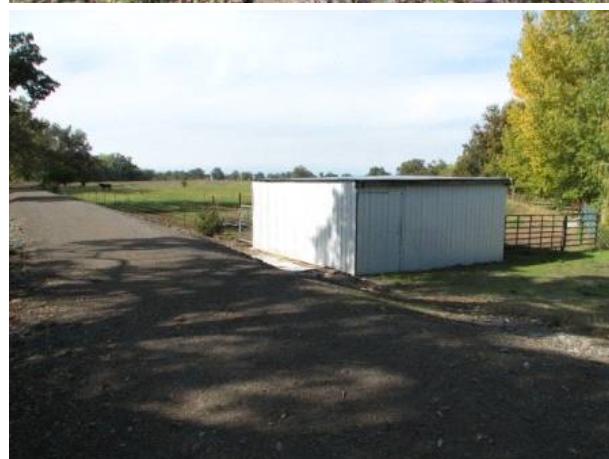
Levee Mile Report Line	3
Start Levee Mile	0.36
End Levee Mile	0.36
Location	Land Side
Category	Earthen Levee
Item	Encroachments
View of building at toe of levee.	
rduffey_f_20130919_021.jpg

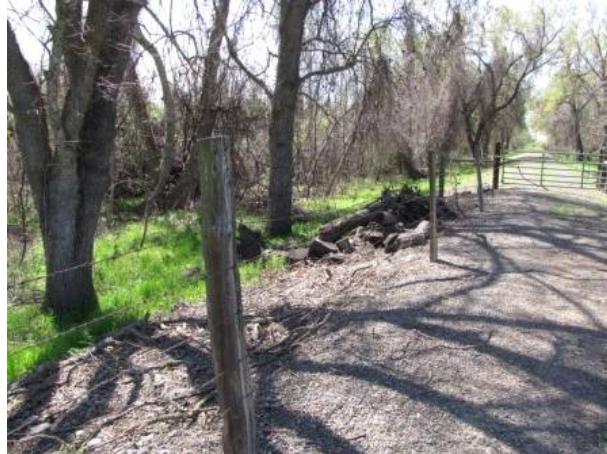
Levee Mile Report Line	5
Start Levee Mile	1.30
End Levee Mile	1.30
Location	Water Side
Category	Earthen Levee
Item	Encroachments
Remove all firewood.

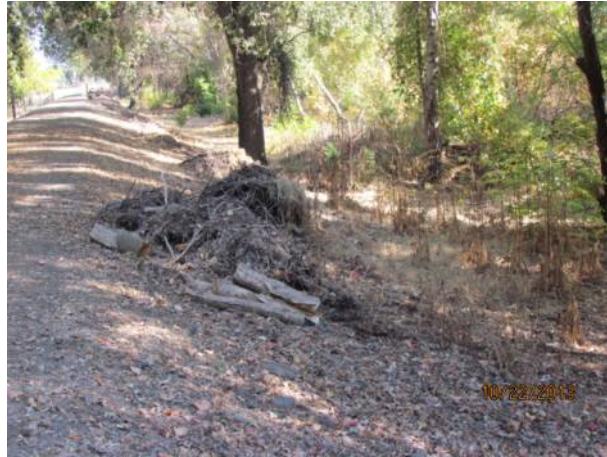
Levee Mile Report Line	6
Start Levee Mile	1.39
End Levee Mile	1.39
Location	Water Side
Category	Earthen Levee
Item	Encroachments
View of the debris along the waterside slope of the levee.

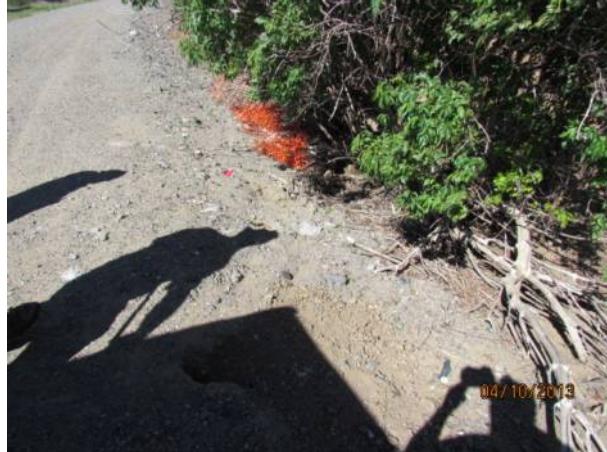
Levee Mile Report Line	1
Start Levee Mile	1.41
End Levee Mile	1.41
Location	Land Side
Category	Earthen Levee
Item	Animal Control
View of the rodent holes along the landside slope.	
rduffey_f_20130919_027.JPG

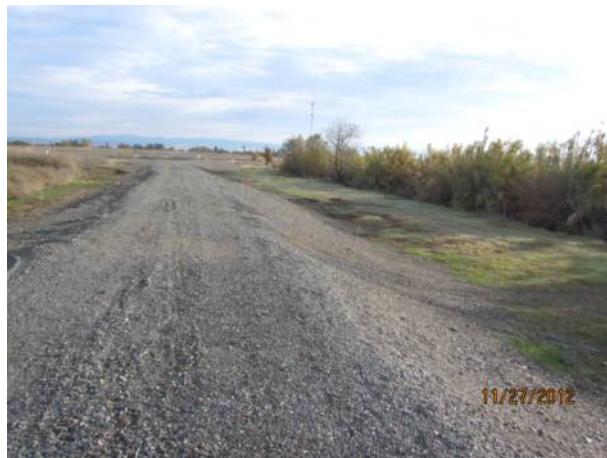
Levee Mile Report Line	3
Start Levee Mile	1.60
End Levee Mile	1.71
Location	Water Side
Category	Earthen Levee
Item	Slope Stability
View of the levee slopes damaged by vehicle traffic.	
rduffey_f_20130919_024.JPG

DWR ID:			
3	1.60	1.71	Earthen Levee	Slope Stability	WS Ma	M	S3 : Repair the levee slope damaged by vehicle traffic and prevent access where possible. Inspector Comments: Tehama Co. repaired the slope that was damaged by vehicle traffic, but the damage has returned.	40.052607 °	40.053558 °	3	
								-122.161418 °	-122.159903 °	Y	
								DWR ID: DWR_04_s_2012_3			
4	2.32	2.32	Earthen Levee	Slope Stability	LS Ma	M	S3 : Repair the levee slope damaged by vehicle traffic and prevent access where possible.	40.052415 °	40.052415 °	18	
								-122.149208 °	-122.149208 °	Y	
								DWR ID: DWR_NA0019_04_s_2012_18			
5	2.34	2.34	Earthen Levee	Slope Stability	LS Ma	M	S3 : Repair the levee slope damaged by vehicle traffic and prevent access where possible.	40.052443 °	40.052443 °	12	
								-122.148863 °	-122.148863 °	Y	
								DWR ID: DWR_NA0019_04_f_2013_12			
6	2.46	2.46	Earthen Levee	Slope Stability	LS Ma	M	S3 : Repair the levee slope damaged by vehicle traffic and prevent access where possible.	40.052417 °	40.052417 °	20

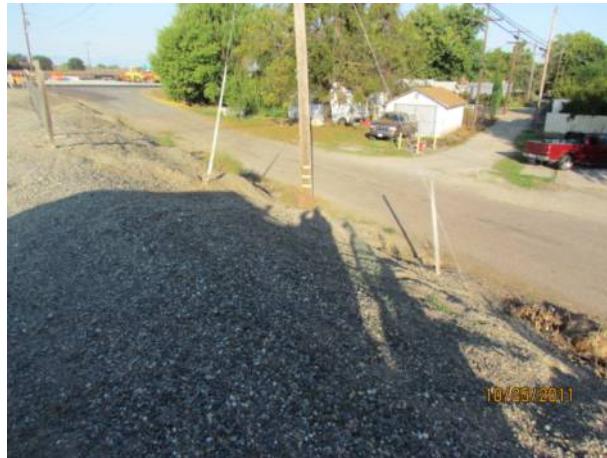
Levee Mile Report Line	4
Start Levee Mile	2.32
End Levee Mile	2.32
Location	Land Side
Category	Earthen Levee
Item	Slope Stability
View of the vehicle erosion along the L/S slope.	
rduffey_f_20130919_030.jpg

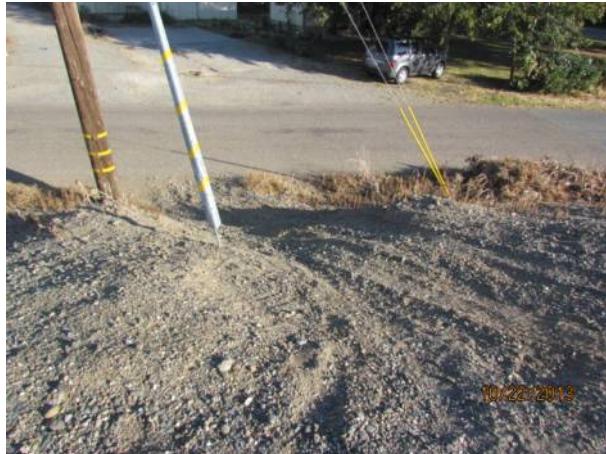
Levee Mile Report Line	5
Start Levee Mile	2.34
End Levee Mile	2.34
Location	Land Side
Category	Earthen Levee
Item	Slope Stability
View of the vehicle erosion along the landside slope.	
rduffey_f_20131104_108.JPG

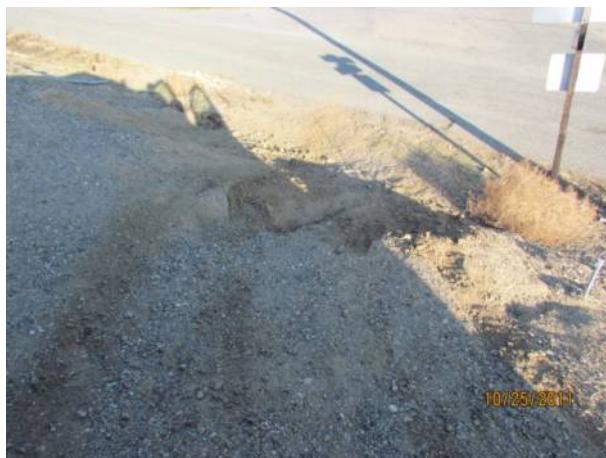
Levee Mile Report Line	6
Start Levee Mile	2.46
End Levee Mile	2.46
Location	Land Side
Category	Earthen Levee
Item	Slope Stability
View of the vehicle erosion along the L/S slope.	
rduffey_f_20130919_031.jpg

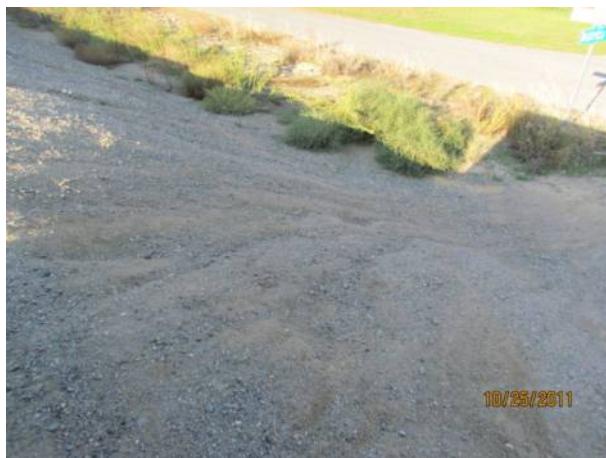
Levee Mile Report Line	7
Start Levee Mile	2.53
End Levee Mile	2.53
Location	Land Side
Category	Earthen Levee
Item	Slope Stability
View of the vehicle erosion along the L/S slope.	
rduffey_f_20130919_023.jpg

-122.146747 °	-122.146747 °	Y	
								DWR ID: DWR_NA0019_04_s_2012_20			
7	2.53	2.53	Earthen Levee	Slope Stability	LS Ma	M	S3 : Repair the levee slope damaged by vehicle traffic and prevent access where possible.	40.052872 °	40.052872 °	2	
								-122.145495 °	-122.145495 °	Y	
								DWR ID: DWR_NA0019_04_s_2012_2			
8	2.66	2.66	Earthen Levee	Encroachments	LS Ma	M	DE : Debris	40.054352 °	40.054352 °	4	
								-122.144245 °	-122.144245 °		
								DWR ID: DWR_NA0019_04_s_2012_4			
9	2.82	2.85	Earthen Levee	Slope Stability	LS Ma	M	S3 : Repair the levee slope damaged by vehicle traffic and prevent access where possible.	40.055033 °	40.055595 °	916	
								-122.141457 °	-122.141203 °		
								DWR ID: DWR_NA0019_04_s_2012_916			
10	3.02	3.02	Earthen Levee	Animal Control	LS Ma	M	A3 : No rodents visible, but rodent burrows visible; need to backfill and compact or grout burrows.	40.056514 °	40.056514 °	5

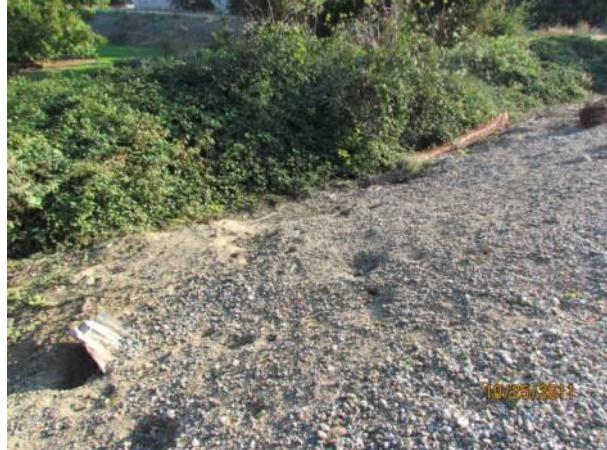
View of the rodent holes along the L/S slope.

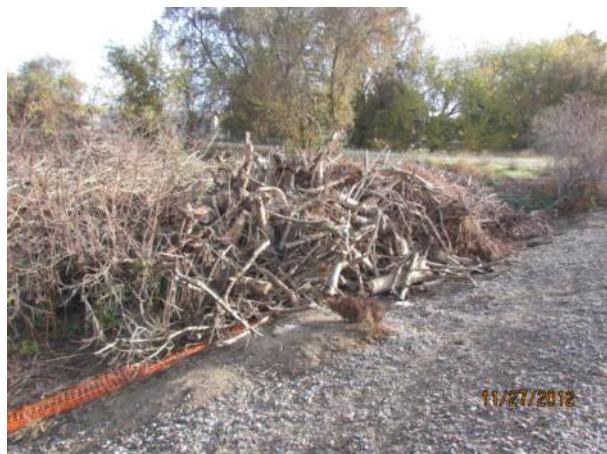
Levee Mile Report Line	11
Start Levee Mile	3.03
End Levee Mile	3.03
Location	Land Side
Category	Earthen Levee
Item	Encroachments

View of the brush pile next to the levee slope.

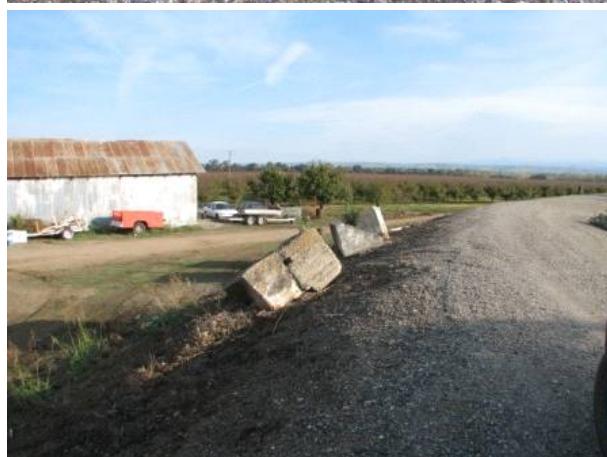
Levee Mile Report Line	13
Start Levee Mile	3.15
End Levee Mile	3.15
Location	Land Side
Category	Earthen Levee
Item	Encroachments

View of the concrete stairways on the slope.

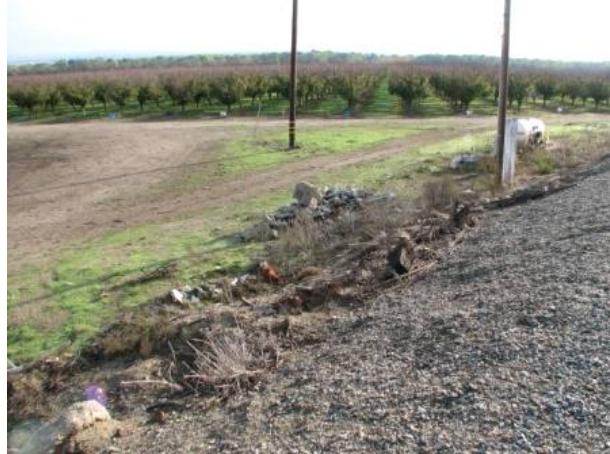
Levee Mile Report Line	14
Start Levee Mile	3.34
End Levee Mile	3.34
Location	Land Side
Category	Earthen Levee
Item	Encroachments
View of the garbage and metal at the toe of the levee & along the slope of the landside.	
rduffey_f_20130919_026.jpg

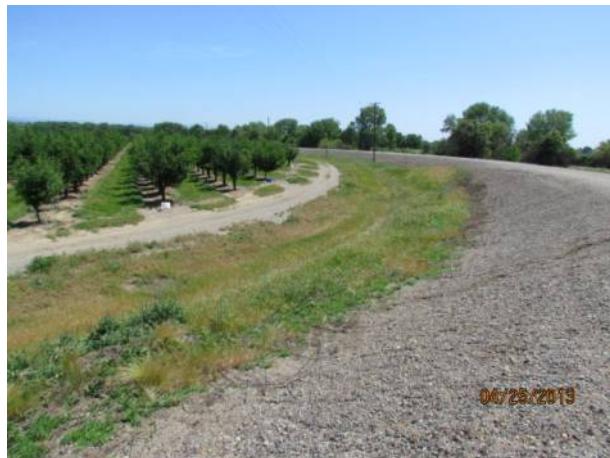
Levee Mile Report Line	15
Start Levee Mile	3.42
End Levee Mile	3.65
Location	Land Side
Category	Earthen Levee
Item	Encroachments
View of the ditch along landside toe.	
rduffey_f_20130919_028.JPG

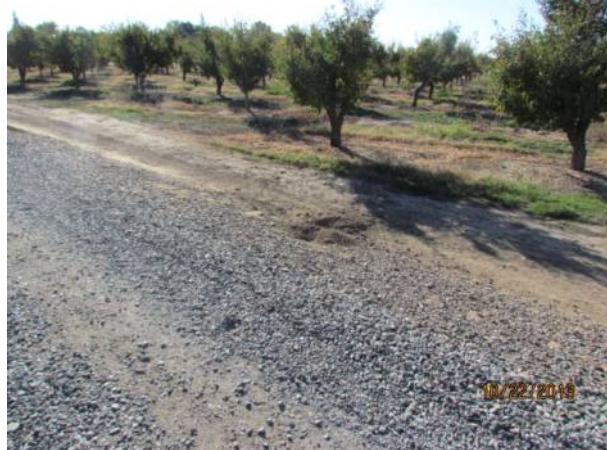
Levee Mile Report Line	1
Start Levee Mile	0.42
End Levee Mile	0.42
Location	Land Side
Category	Earthen Levee
Item	Animal Control
View of the rodent holes along the landside slope.	
rduffey_f_20131104_109.JPG

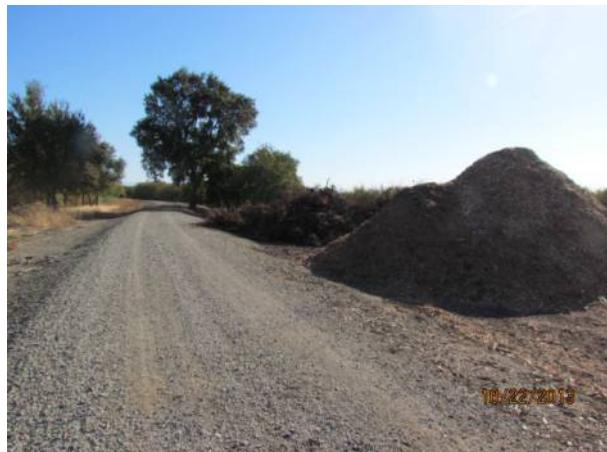
Levee Mile Report Line	2
Start Levee Mile	0.81
End Levee Mile	0.81
Location	Land Side
Category	Earthen Levee
Item	Encroachments
View of the prunings along the landside slope.	
rduffey_f_20131104_110.JPG

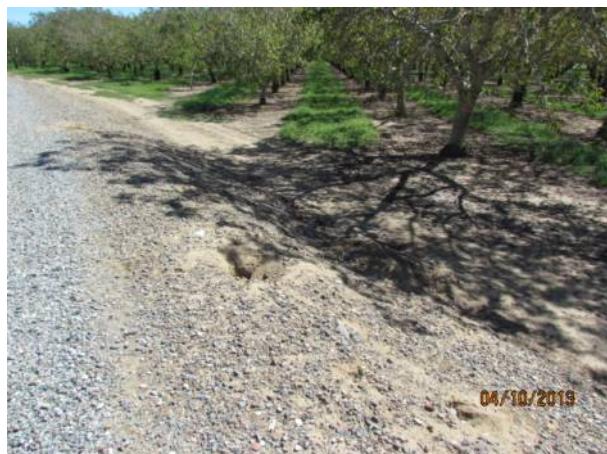
Levee Mile Report Line	3
Start Levee Mile	0.94
End Levee Mile	0.94
Location	Land Side
Category	Earthen Levee
Item	Animal Control
View of the rodent holes along the levee slope.	
rduffey_f_20130919_033.JPG

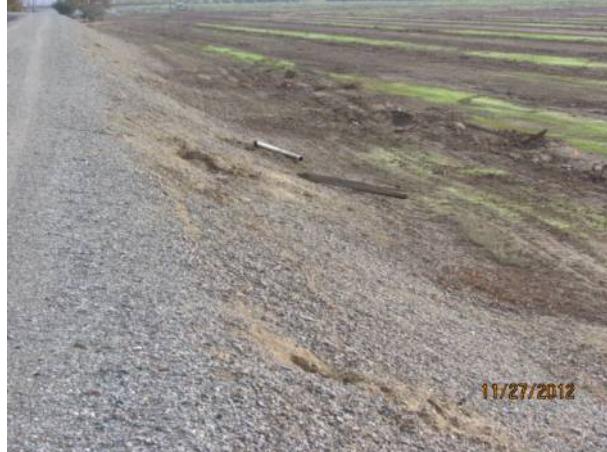
Levee Mile Report Line	4
Start Levee Mile	2.55
End Levee Mile	2.55
Location	Water Side
Category	Earthen Levee
Item	Animal Control
View of the rodent activity along the landside slope.	
rduffey_f_20130919_034.JPG

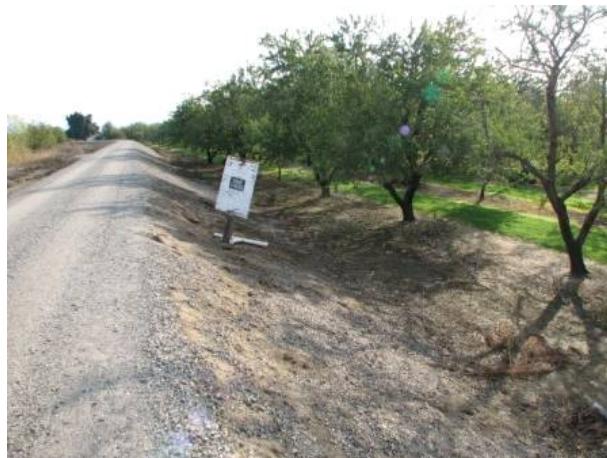
Levee Mile Report Line	5
Start Levee Mile	2.57
End Levee Mile	2.57
Location	Land Side
Category	Earthen Levee
Item	Animal Control
View of the bait station next to the squirrel holes on the landside slope.	
rduffey_f_20130919_036.jpg

-122.148531 °	-122.148531 °	Y	
								DWR ID: DWR_NA0019_05_s_2012_5			
5	2.57	2.57	Earthen Levee	Animal Control	LS M Ma	A1 : Exterminate rodents and backfill and compact or grout burrows.		40.051675 °	40.051675 °	8	
								-122.148122 °	-122.148122 °	Y	
								DWR ID: DWR_NA0019_05_s_2012_8			
6	2.70	2.76	Earthen Levee	Vegetation	LS M En	V6 : Landscaping		40.051778 °	40.052243 °	2	
								-122.145745 °	-122.144825 °	Y	
								DWR ID: DWR_NA0019_05_s_2012_2			
7	3.08	3.10	Supplemental USACE Erosion Survey	WS M Ma	Inspector Comments: 2006 - Mass failure of this bank due to being along the outside of a bend where erosion and undercutting are the greatest. Low flow is being forced into the toe of this bank by point bar on the opposite side of the creek. 2011 - Toe of the bank continues to be undercut. 2012: Site is part of the extended inventory, last inspected 2011. [2012 Site ID: ELC_3-0_R]			40.054730 °	40.054970 °	3

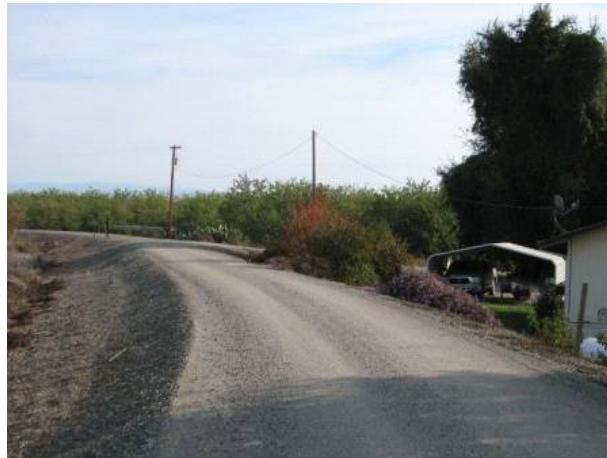
Levee Mile Report Line	6
Start Levee Mile	2.70
End Levee Mile	2.76
Location	Land Side
Category	Earthen Levee
Item	Vegetation
View of the landscape along the slope.	
rduffey_f_20130919_032.jpg

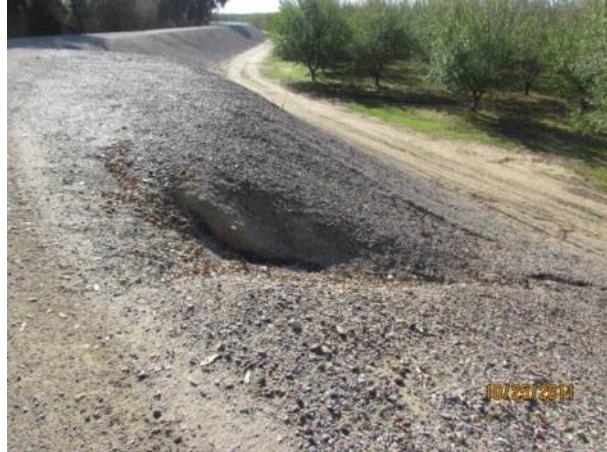
Levee Mile Report Line	10
Start Levee Mile	3.45
End Levee Mile	3.45
Location	Land Side
Category	Earthen Levee
Item	Erosion / Bank Caving
View of the erosion along the L/S slope.	
rduffey_f_20130919_035.jpg
